CERL Technical Report 99/37  
May 1999

# **Robotic Underwater Corrosion Inspection/Assessment of Sheet Pile Along Two Rivers at Cleveland, Ohio**

## **Cuyahoga River Bulkhead Study: Phase 2 Report**

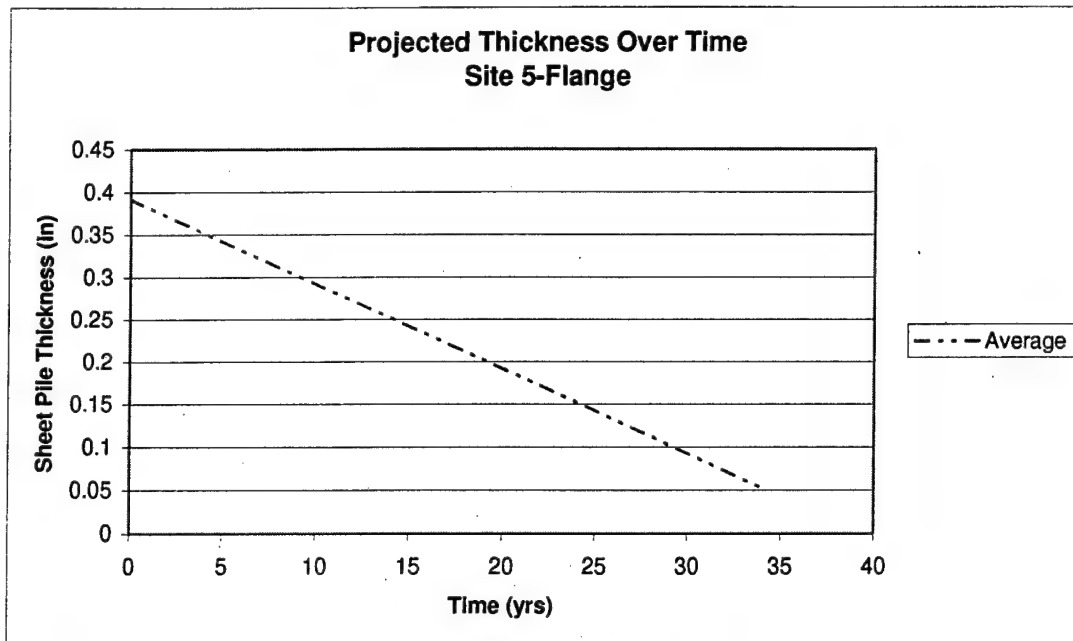
Figure 15. Site 5 flange thickness projected over time. Note: There were too few reliable measurements to determine a valid max/min range in this case.

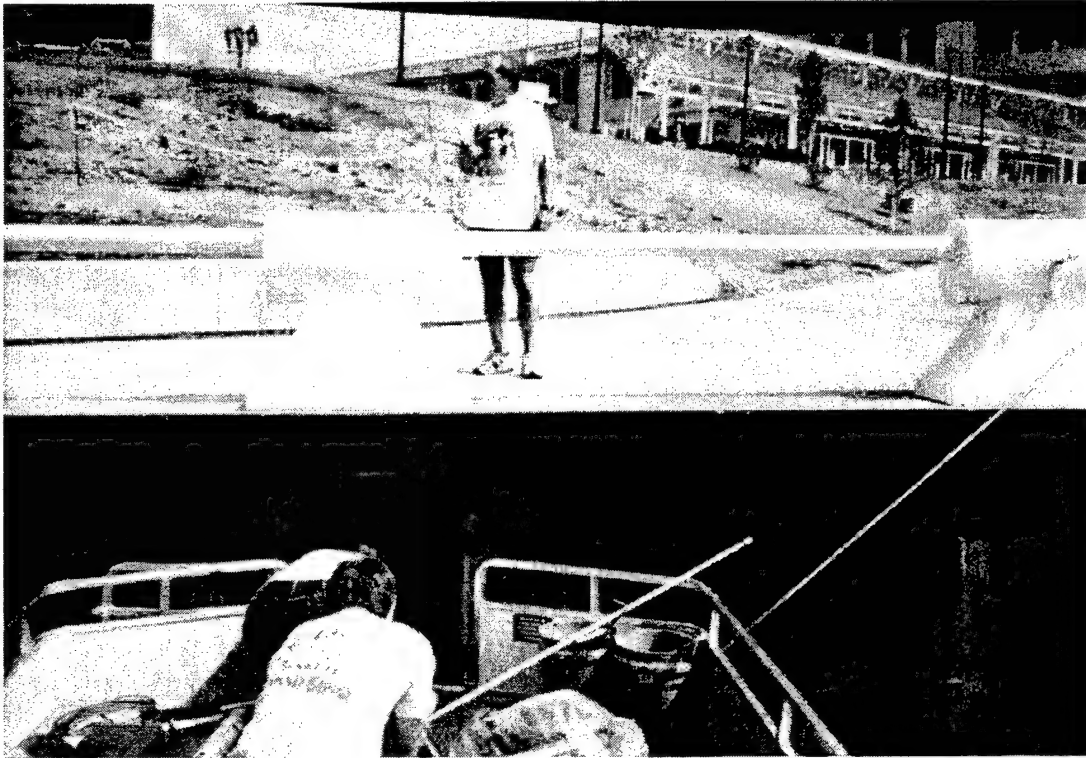
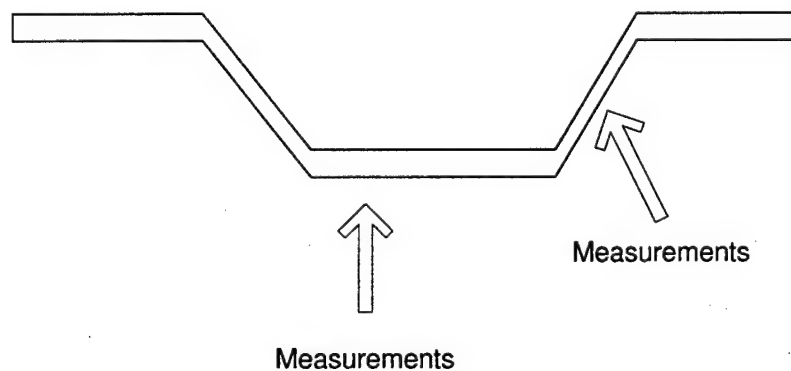
## Site 1

Site 1 Location: Parks1/Parks 3, City of Cleveland Parks and Recreation, next to Frank Morrison and Son; just north of marker 540 on east shore.

Type of sheet pile: cold-rolled.

Measurements: Taken on the northeastern side approximately 40 ft upriver from water fountain. Measurements were taken on the flange and the web of the sheet pile.

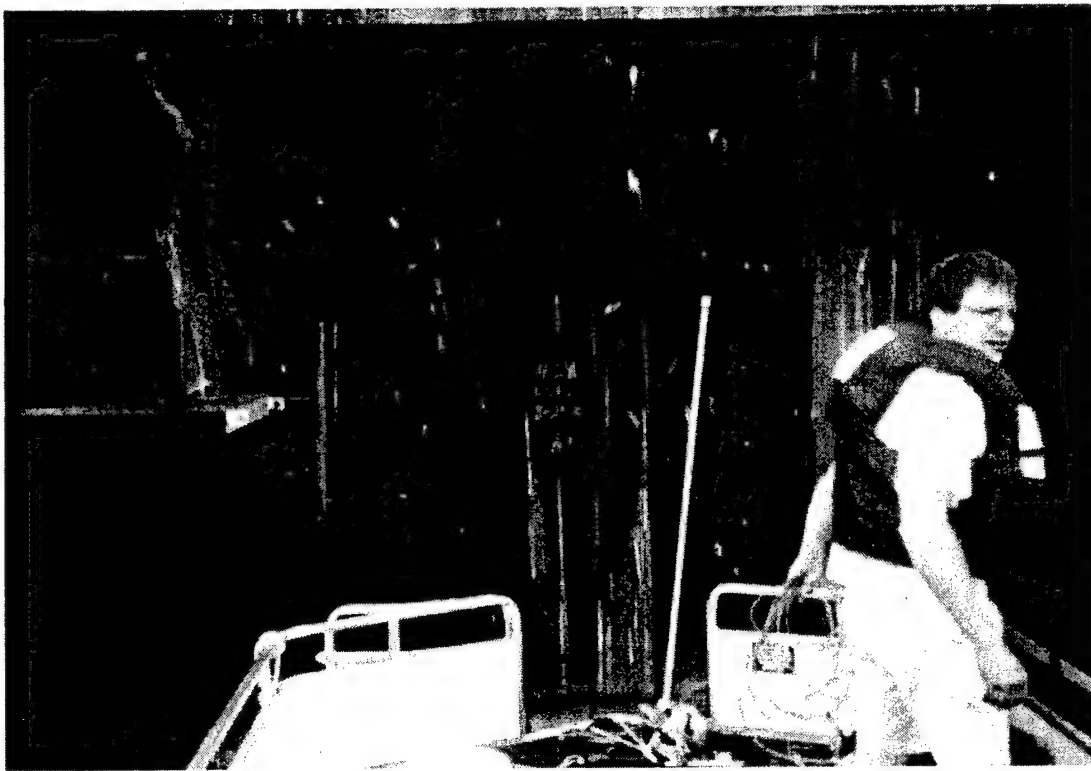
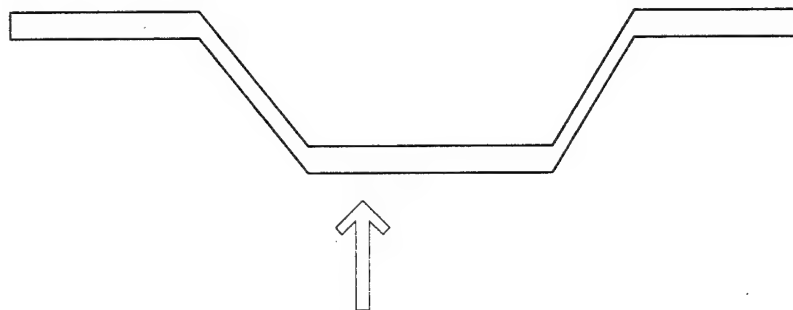
**Site 2**

Site 2 Location: Glazer 4/City of Cleveland 32 or City of Cleveland 31, approximately 400 ft south of Site 1 between markers 540 and 548 on east shore.

Type of sheet pile: cold-rolled.

Measurements: Taken from the first full sheet pile section down from the platform on the bulkhead. All measurements were taken on the flange of the sheet pile.

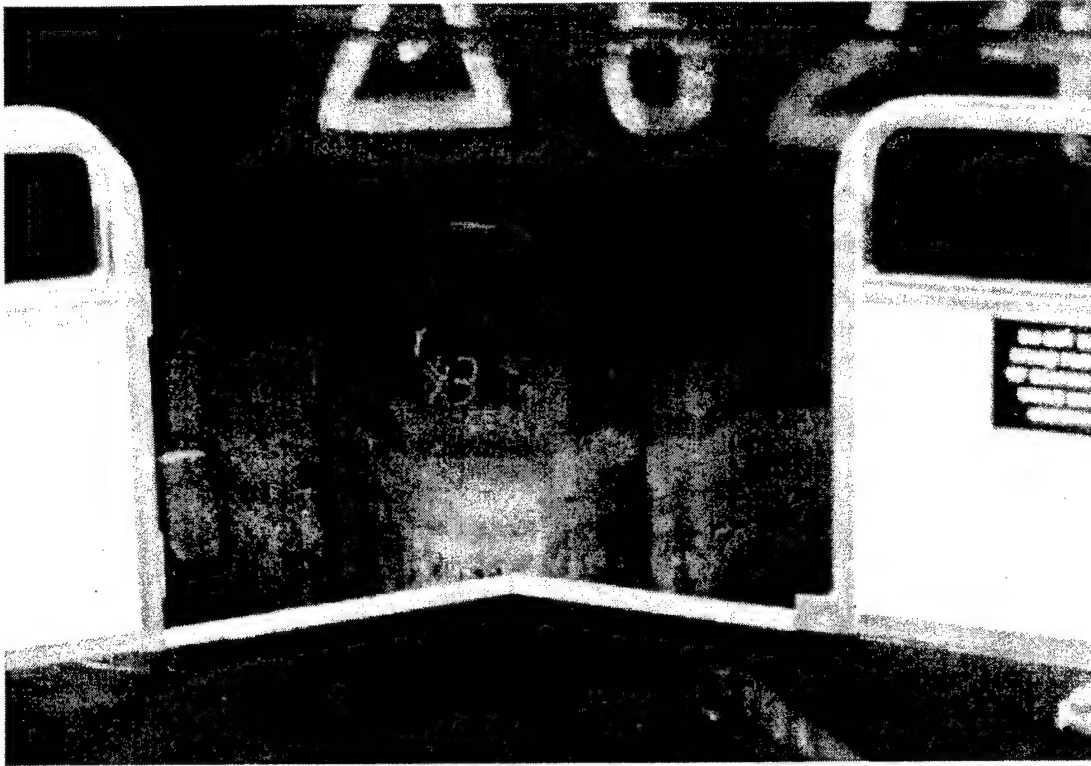
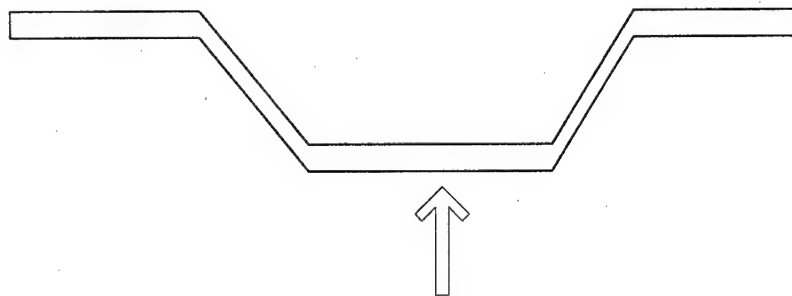
**Site 3**

Site 3 Location: Cereal 1 / Cereal 2 or Cereal Food Processors 3, just north of marker 559 on the east shore.

Type of sheet pile: hot-rolled in front.

Measurements: Taken below the yellow triangle next to the 624A marker on the sheet pile, near the northwest corner of the grain loading tower. All measurements were taken on the flange of the hot-rolled sheet pile.

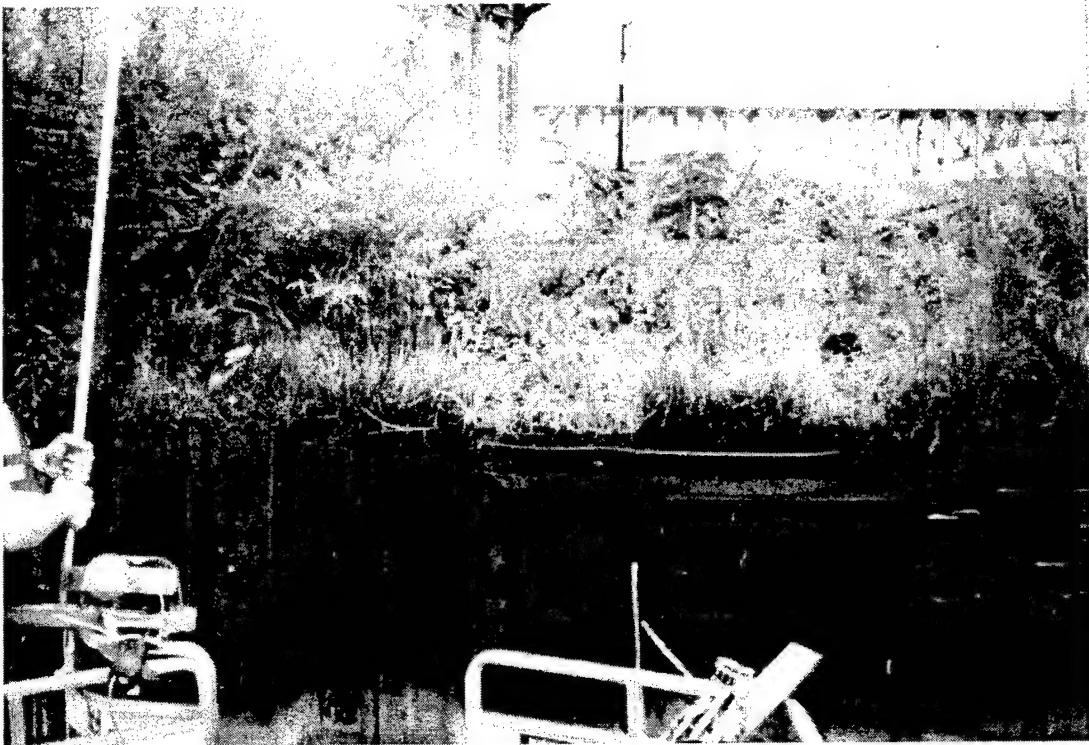
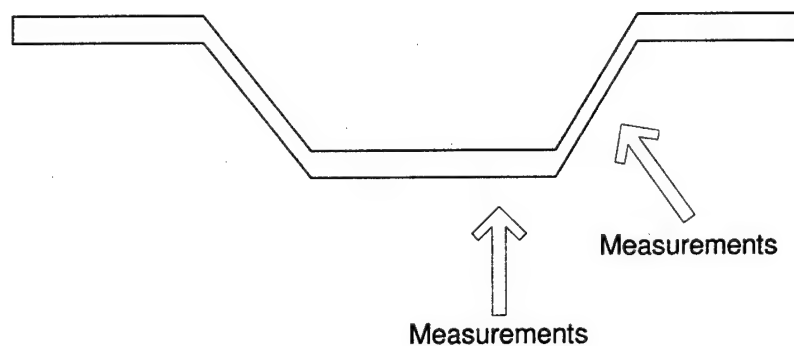
**Site 4**

Site 4 Location: Mid-Continental Coal/Coke 2, halfway between markers 640 and 650 on the east shore.

Type of sheet pile: hot-rolled.

Measurements: Measurements taken close to the 650 sheet pile marker. Measurements were taken on the flange of the sheet pile by Fury and Panametrics. Panametrics measurements were also taken on the web.

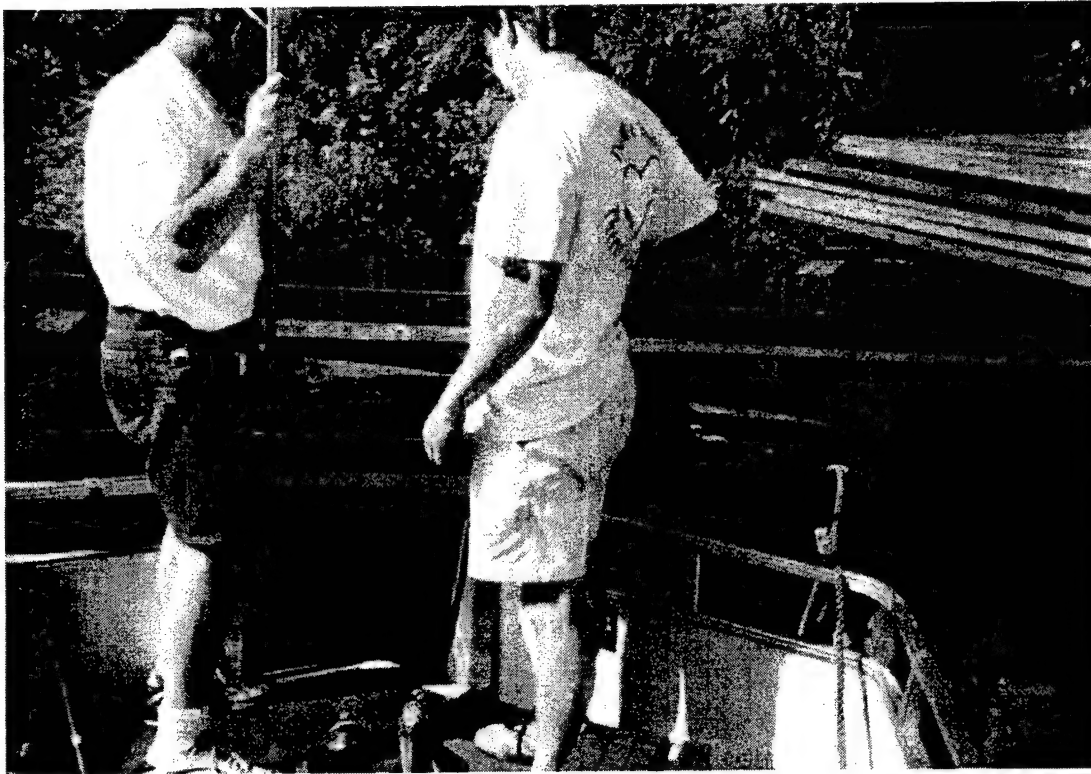
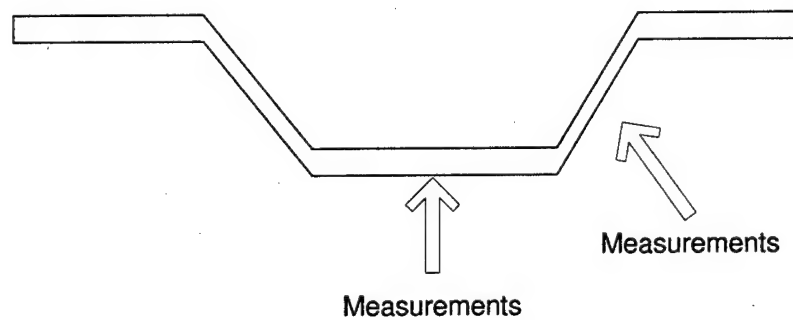
## Site 5

Site 5 Location: Erie RR 10/Sta Realty 2, on outcropping between markers 660 and 670, closer to 670 on west shore.

Type of sheet pile: hot-rolled.

Measurements: Two measurements were taken on the web by Panametrics. All other measurements were taken on the flange by Fury and Panametrics.

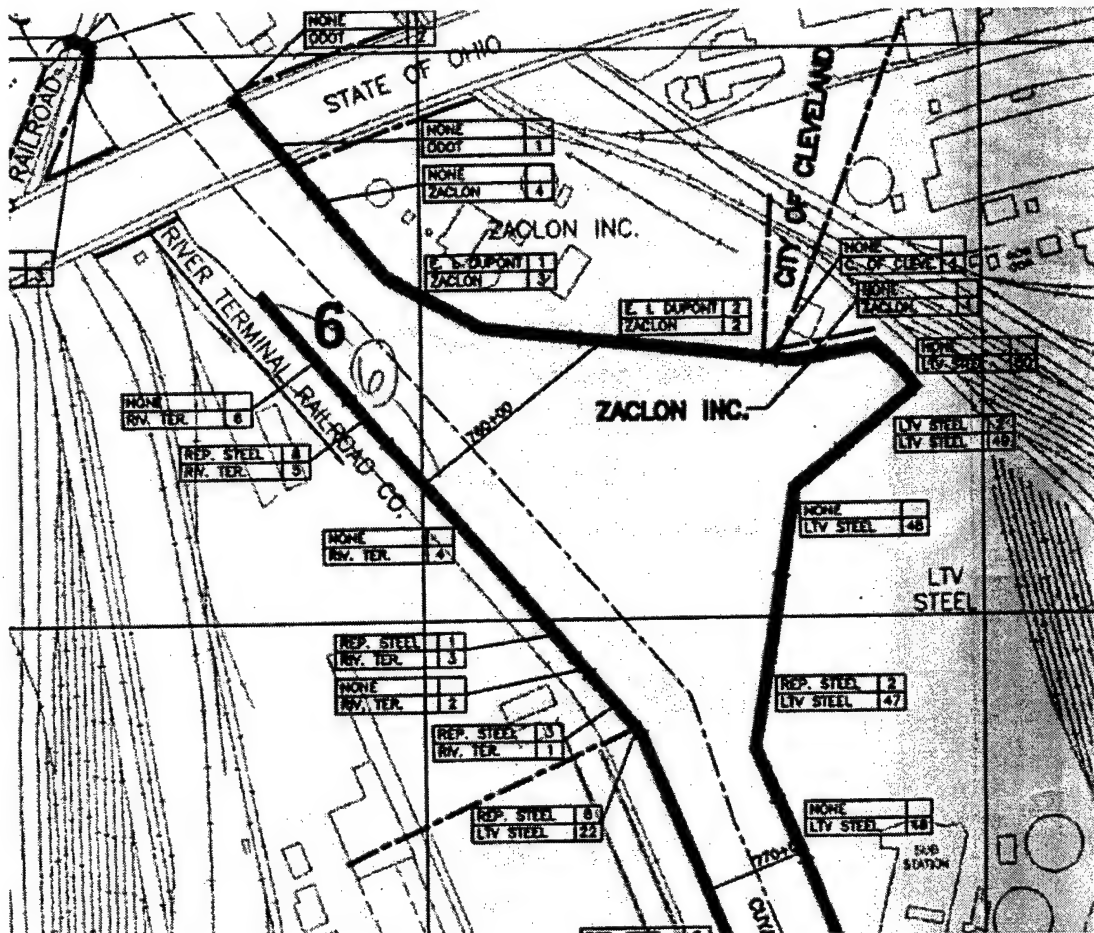
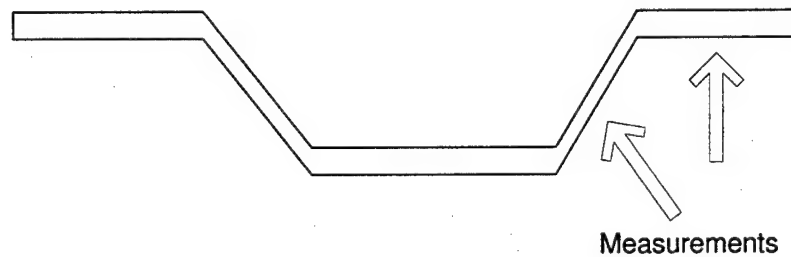
## Site 6

Site 6 Location: River Terminal 6, just north of marker 760 on southwest shore.

Type of sheet pile: hot-rolled.

Measurements: Measurements were taken on the back flange of the sheet pile by Fury. Panametrics measurements were taken on the web.

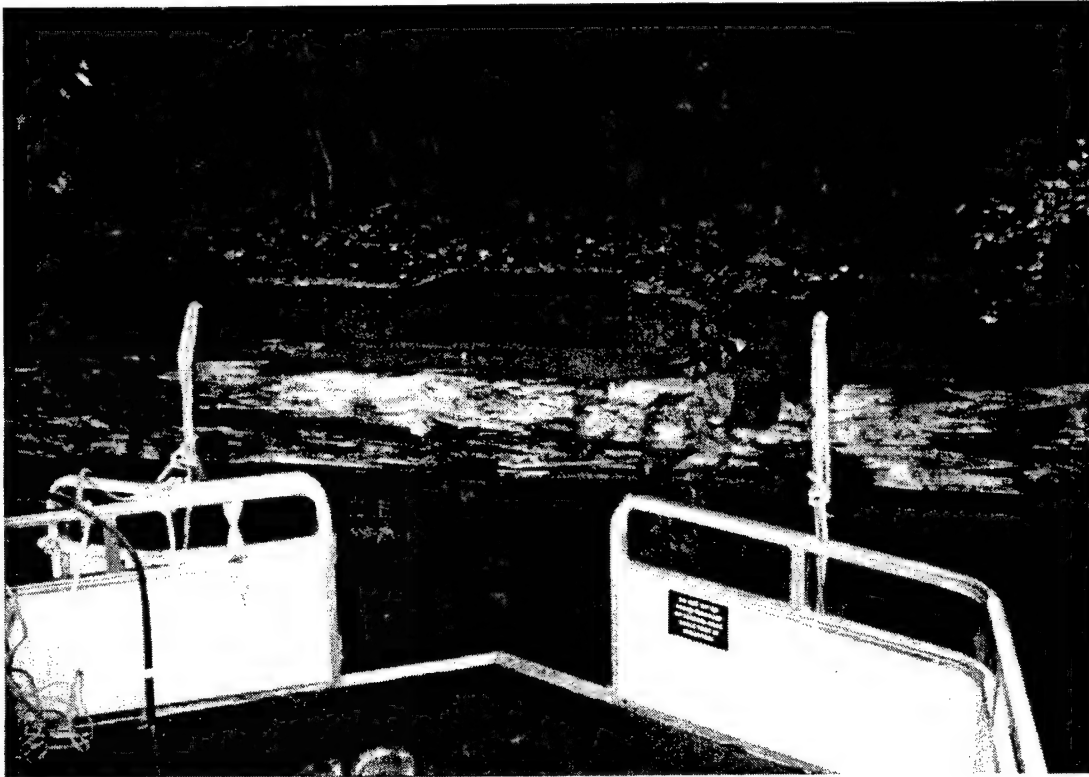
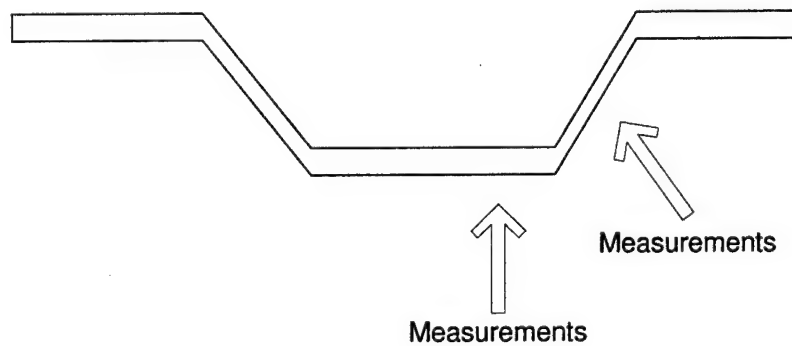
**Site 7**

Site 7 Location: Carter 1, between Samsel Realty and Carter Peninsula; just south of marker 610 on the east shore.

Type of sheet pile: hot-rolled.

Measurements: Taken near station 610+00. Two measurements were taken on the flange of the sheet pile by Panametrics. All other measurements were taken by Fury and Panametrics on the web.

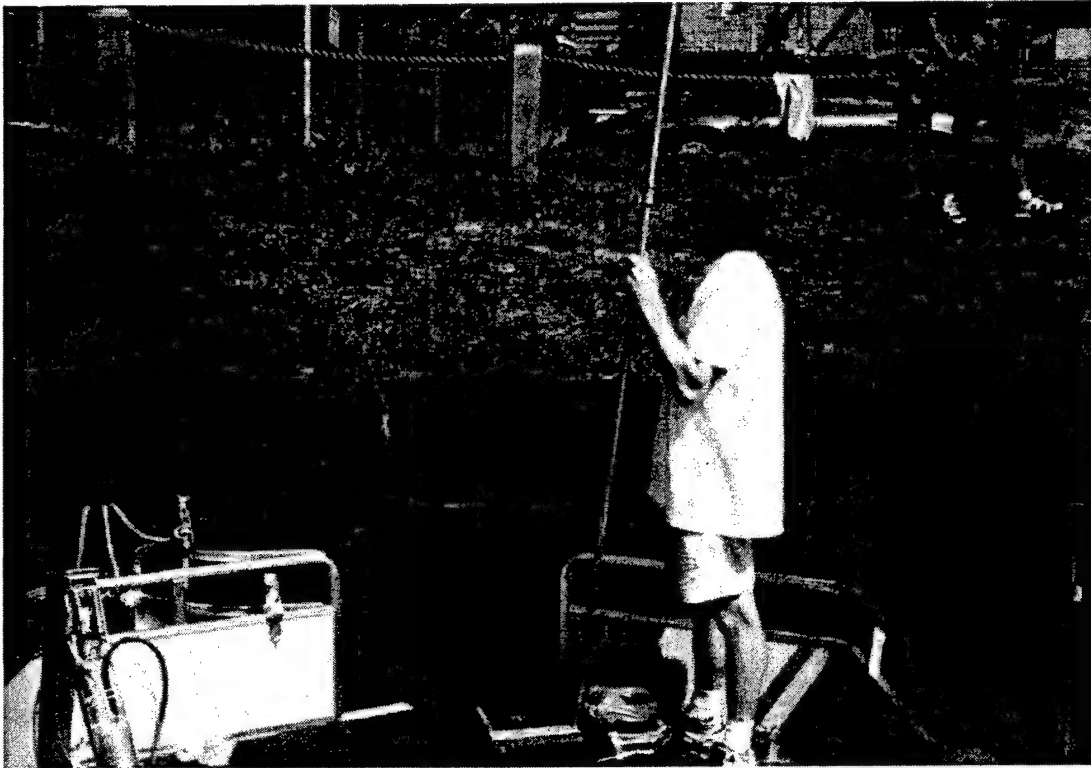
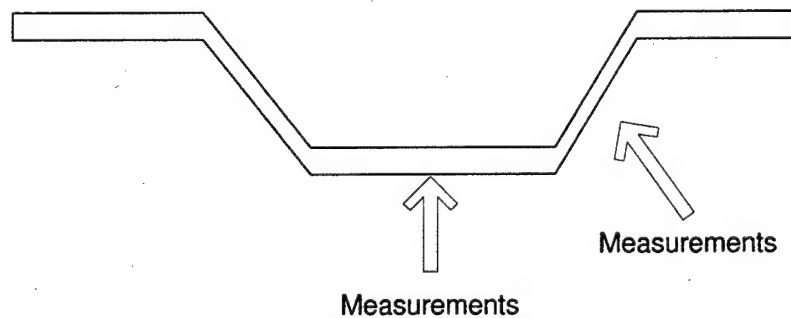
## Site 8

Site 8 Location: B&O RR 1/ Tower City 1, between Tower City and F.C. Southridge Corp.; between markers 620 and 630 on the north shore.

Type of sheet pile: hot-rolled.

Measurements: Measurements were taken on the flange of the sheet pile by Fury and Panametrics. Panametrics measurements were also taken on the web.

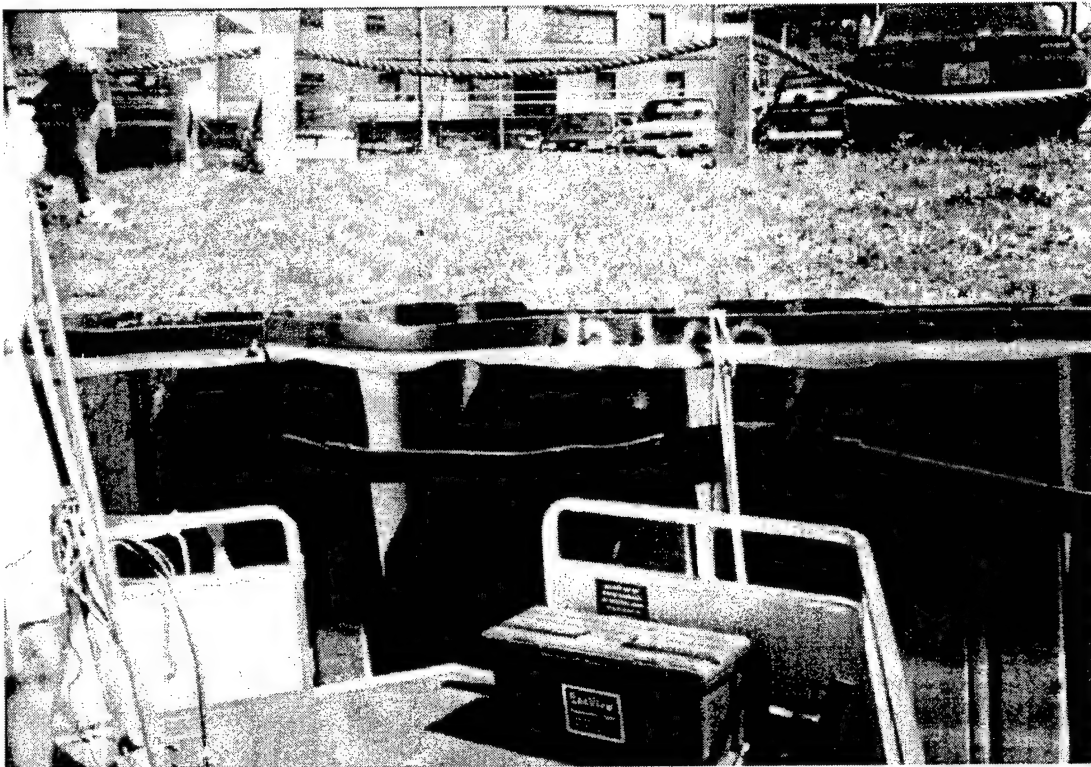
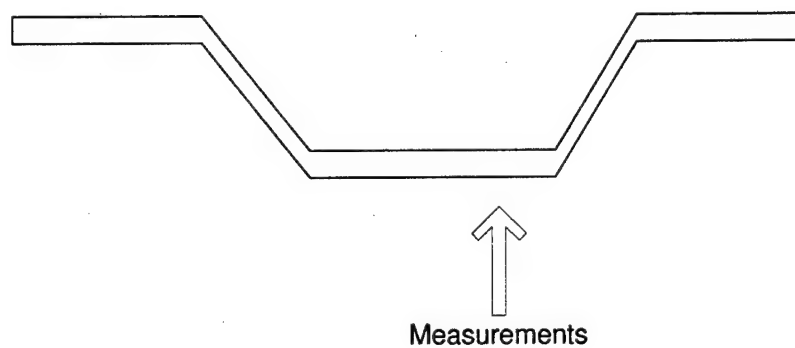
**Site 9**

Site 9 Location: B&O RR 1/Mid-Continental 5, between markers 630 and 640, on east shore.

Type of sheet pile: hot-rolled.

Measurements: All measurements were taken on the flange by Panametrics.

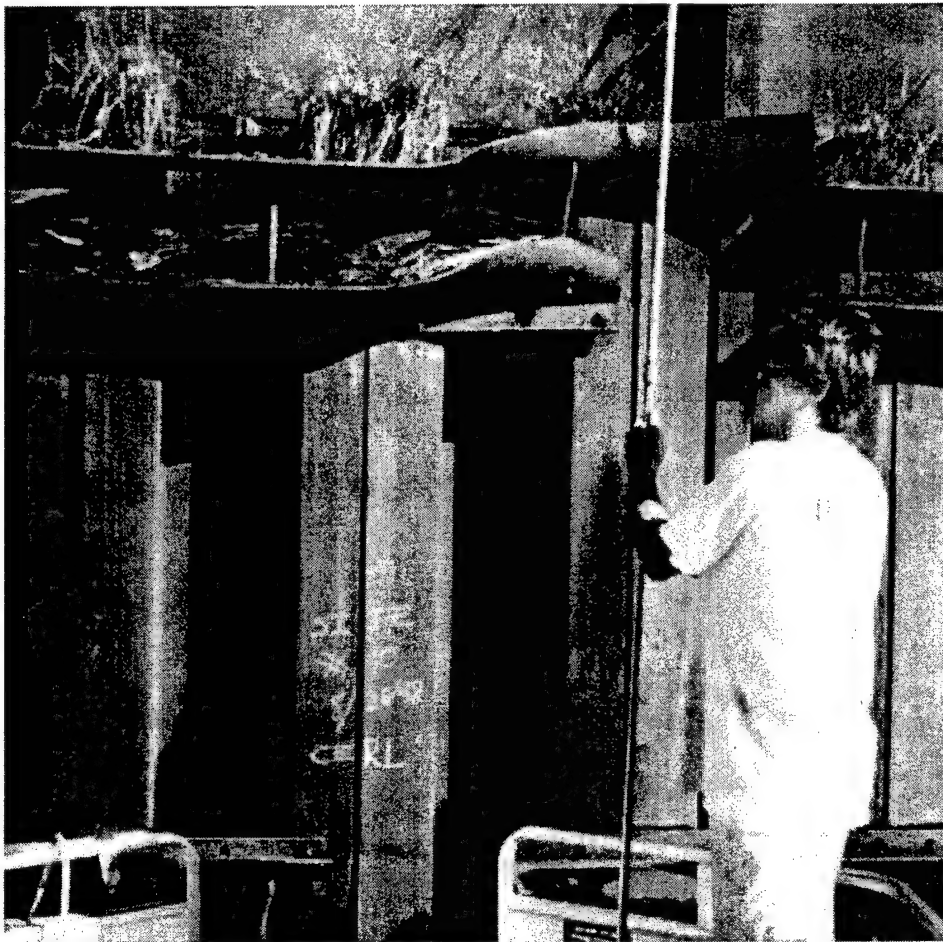
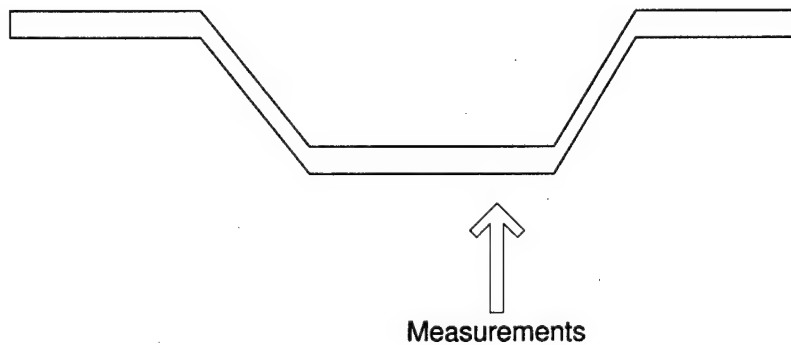
**Site 10**

Site 10 Location: Republic Steel 7/ LTV Steel 31, between 800 and 810 on the east shore.

Type of sheet pile: hot-rolled.

Measurements: Close to station 800+50, at front of Sun Oil terminal. All measurements were taken on the flange of the sheet pile by Fury and Panametrics.

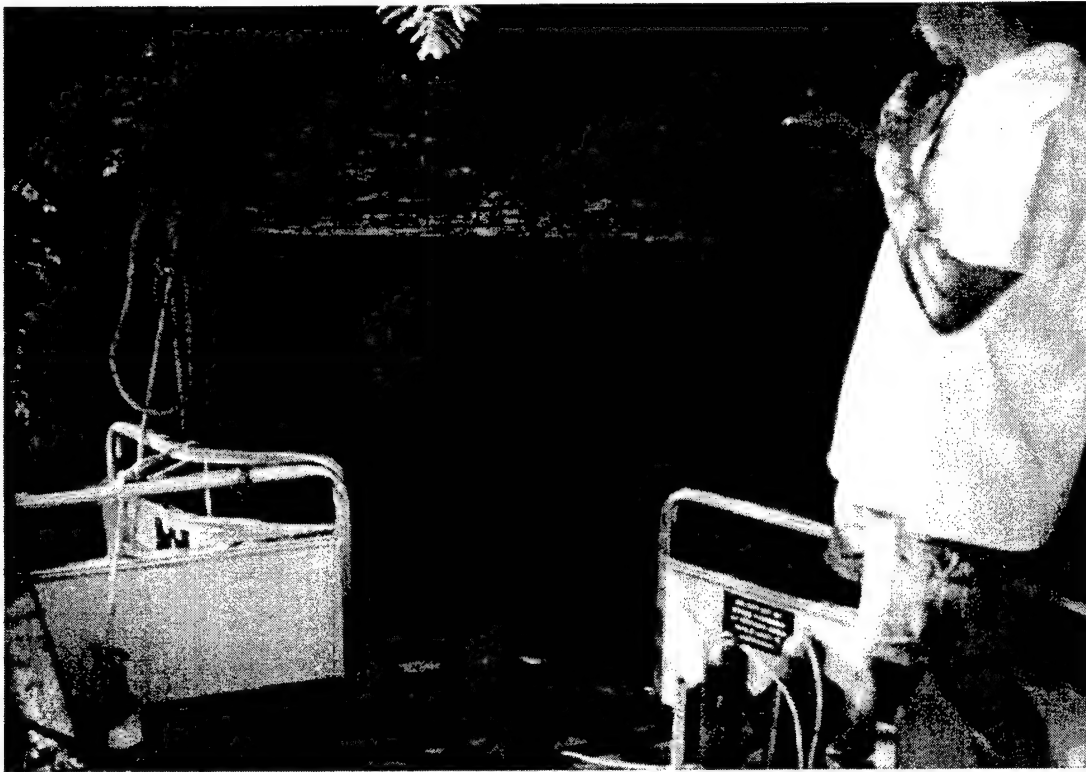
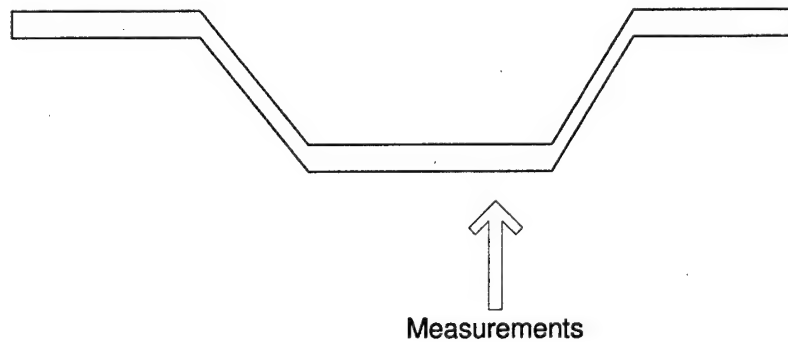
## Site 11

Site 11 Location: B&O Railroad 7 / B&O Railroad 5, slightly east of marker 700 on the north shore.

Type of sheet pile: hot-rolled.

Measurements: All measurements were taken on the flange of the sheet pile by Fury and Panametrics.

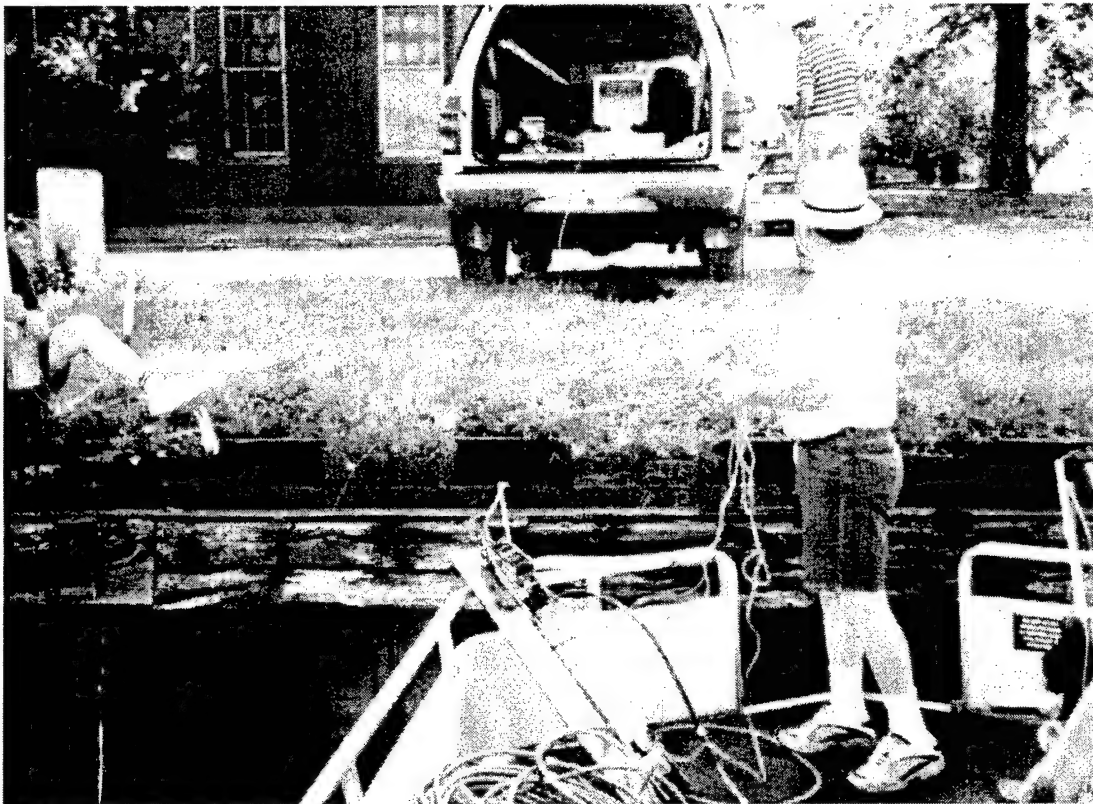
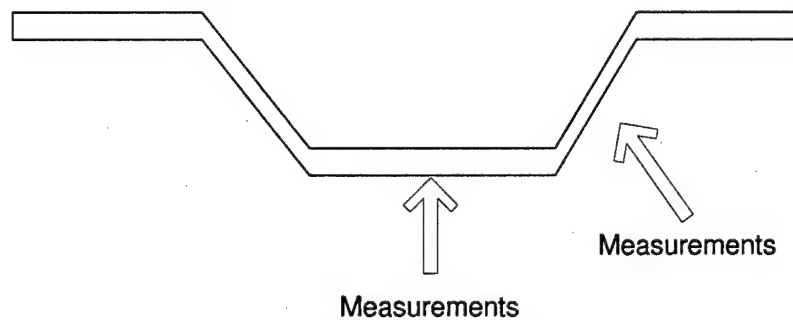
## Site 12

Site 12 Location: Erie RR 6 / Ontario Stone 4, between markers 320 and 310 on the south shore.

Type of sheet pile: hot-rolled.

Measurements: Site near the end of the building. Measurements were taken on the web by Fury and Panametrics. One Panametrics measurement was taken on the flange.

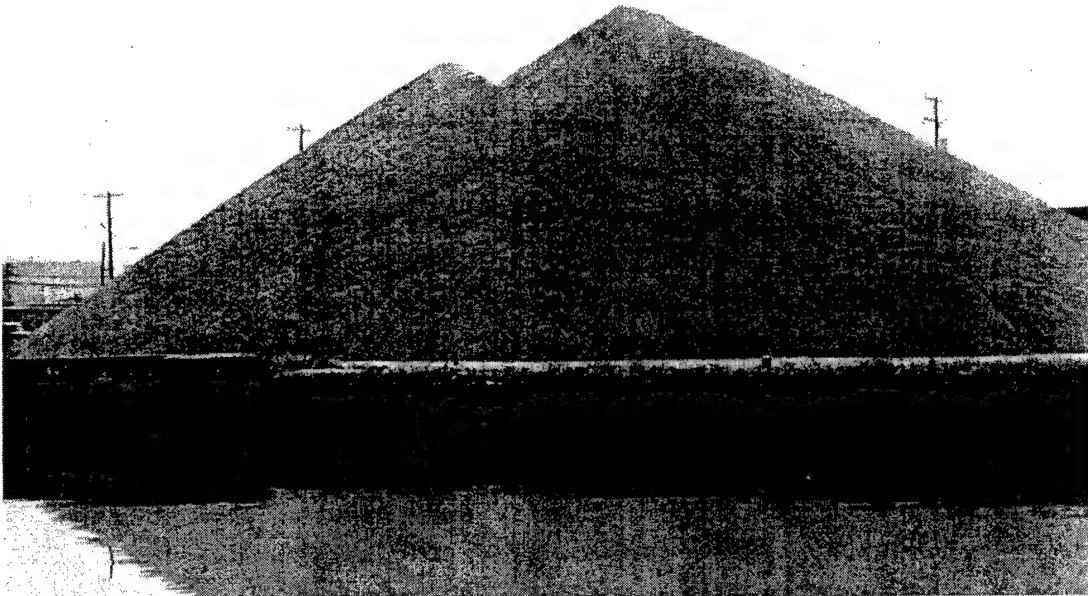
Figure 36. Coal storage at Site 4, the Mid-Continental Coke and Coal property.

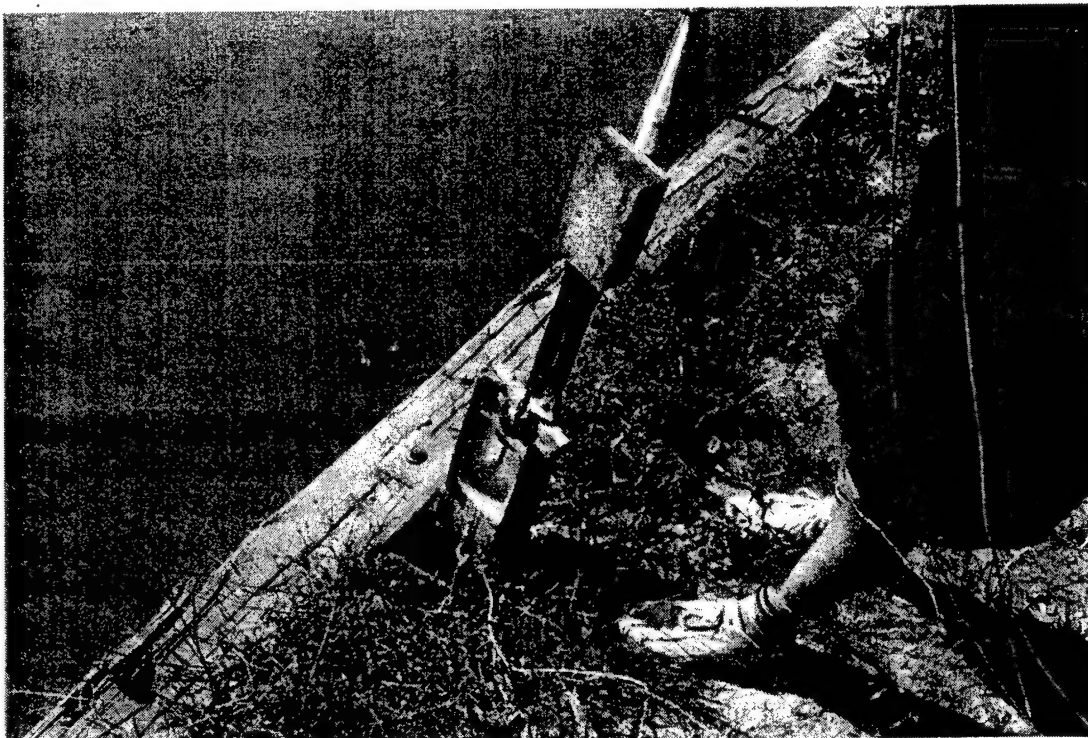
Figure 37. Polarization resistance testing device.

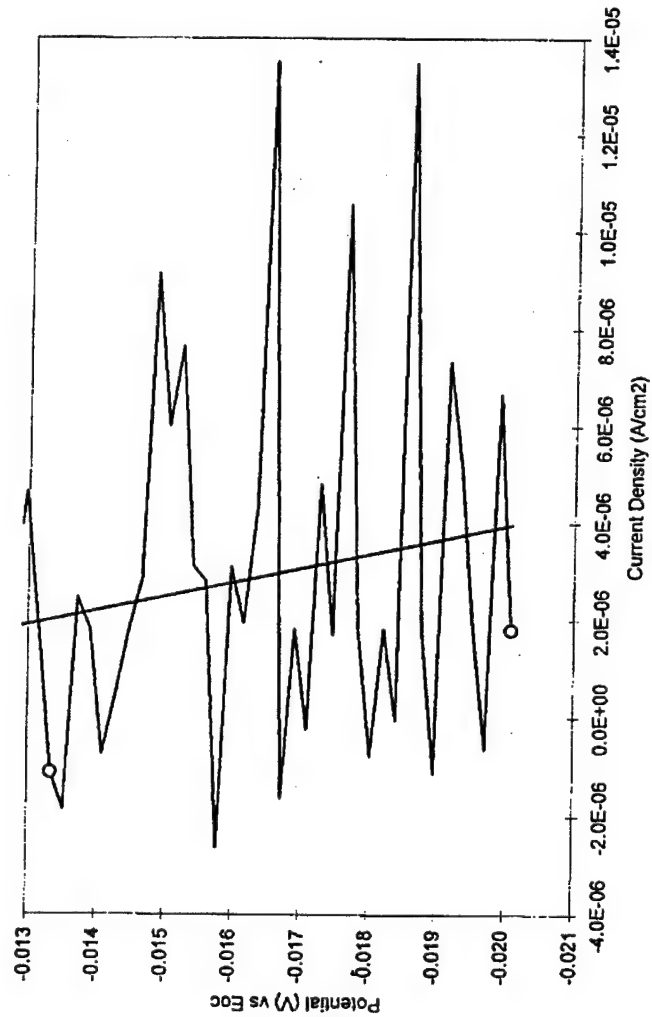
Polarization Resistance  
'coepr#1.dta' 8/24/1998-14:6:9

Region = -20.1 mV to -13.3 mV  
BetaC = 120.0 mV/Decade  
BetaA = 120.0 mV/Decade  
Ecorr = -569.4 mV  
Icorr = -7.594E-06 A/cm<sup>2</sup>  
Rp = -3.431E+03 Ohm cm<sup>2</sup>  
CorrRate = -9.455 mpy

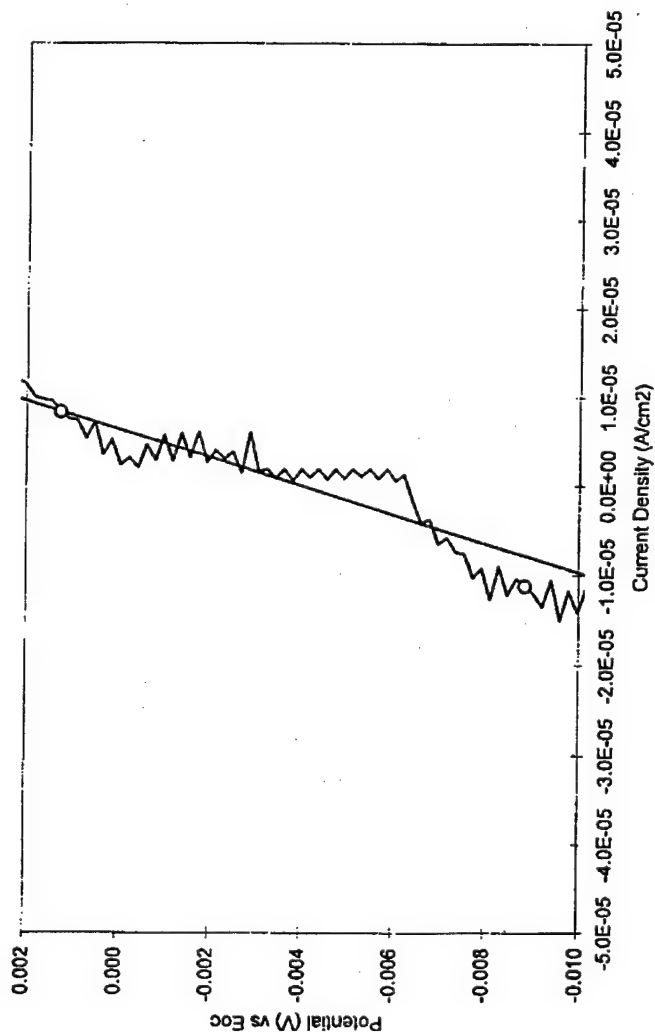
Polarization Resistance  
'coepr#4a.dta' 8/25/1998-12:37:18

Rp = 6.241E+02 Ohm cm<sup>2</sup>

CorrRate = 51.982 mpy
